Generators

Generator change-out at Borger

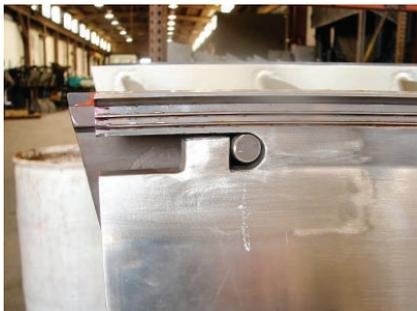
3. Diaphragm equipped with seal-holder anti-rotation device (501F shown)

half seal holder to stop reverse rotation (Fig 3). Note that this mod still allows base-half seal holders to be rolled out around the rotor if necessary.

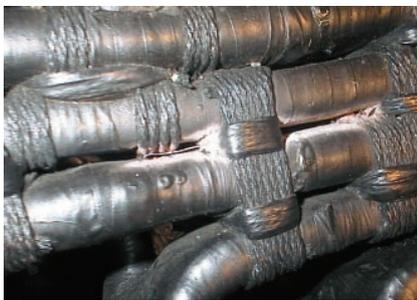
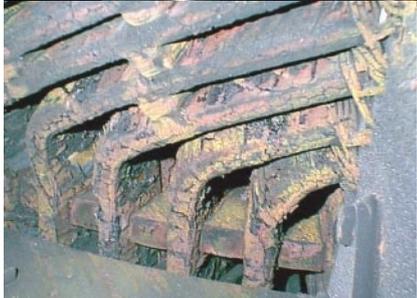
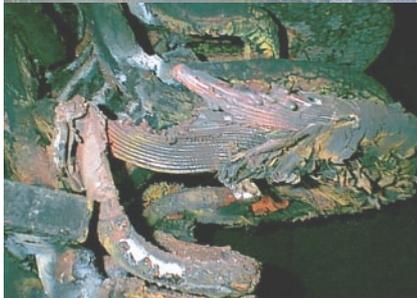
4. Going, going, gone: the progressive stages of winding deterioration

look for in the machine and where. The three photos in Fig 4 that King and Watkins labeled "Going, going, gone" illustrate progressive stages of winding deterioration.

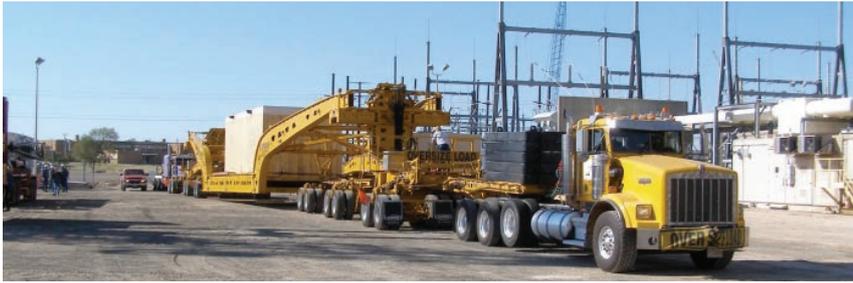
5. Generator was delivered to Blackhawk on a 228-ft-long, 16-ft-wide truck

The generator was manufactured in the UK and trans-shipped to Rotterdam where it was loaded on an ocean-going vessel bound for Houston). The machine was in Borger six days after the ship docked (Fig 5). Rogers started by reviewing all the planning required to swap-out generators, including:

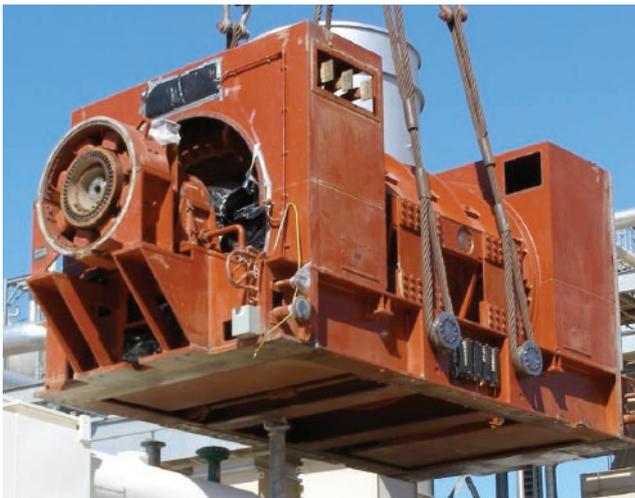
6. Two 300-ton cranes were used to lift out the old and fit new generator into position

- Schedule crane service. Westac load was 367,000 lb, Brush 312,000. Two 300-ton cranes were requested for use in tandem.
- Contract local vendor support, including mechanical, electrical, and machine shop. Last was required to fabricate four lifting trunions to remove the Westac unit. Each trunion weighed 400 lb.
- Temporary installation of a back-up boiler to accommodate thermal host's steam needs during generator replacement.
- Arrange for shipping of the generator from Houston to the plant, including all permits required. The truck contracted was 228 ft long, 16 ft wide, and had a total gross weight of more than 300 tons.
- Controls and procedural changes included DCS (distributed control system) modifications, new operating procedures, and settings/performance verification of a new voltage regulator.

Commissioning was completed soon after installation (Figs 6, 7). It required coordination with the local utility to conduct pre-service tests, calibrate the automatic voltage regulator, and run load tests. All work was completed within two months and operation through the first winter and summer met expectations. Plant dispatched at up to 70% of its capability during that time.

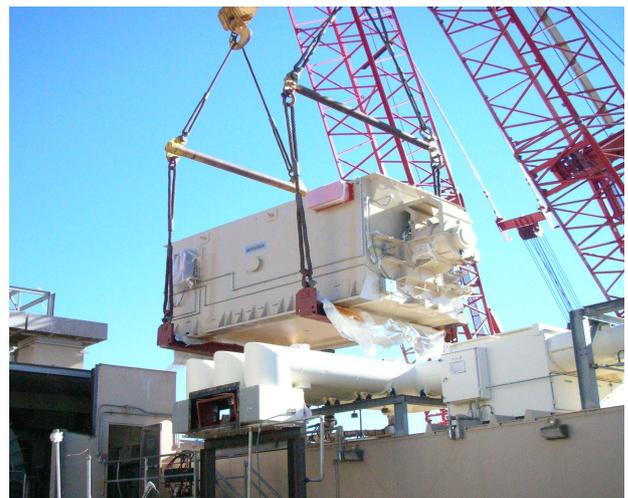
7. Contractors reconditioned existing foundation prior to delivery of the new generator

- Broke couplings and removed starting package.
- Removed air inlet housing and generator enclosure.
- Disconnected neutral and line-side electrical cubicles.
- Removed oil piping and lifted ancillary electrical wiring/instrumentation.
- Removed Westac generator and repaired/modified foundation to accommodate the Brush machine.
- Rebuilt access road to plant, provided crane support for offloading and staging.
